COMMERCIAL WINDSTORM MITIGATION REPORT (OIR-B1-1802)

Inverness Condominium II Association, Inc.

Building 2, 2581 Countryside Blvd, Units 2101-2212, 2301-2313

As of 4/8/2020

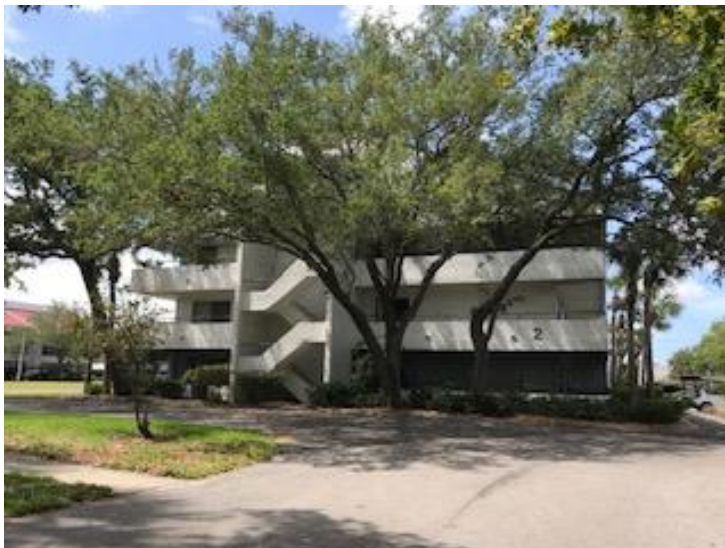
Exterior Elevation

4. **Roof to Wall Attachment:** **Toe Nails**
Comments: Inspection verified embedded straps fastened with less than three nails.
5. **Roof Geometry:** **Other Roof**
Comments: Inspection verified a gable roof shape.

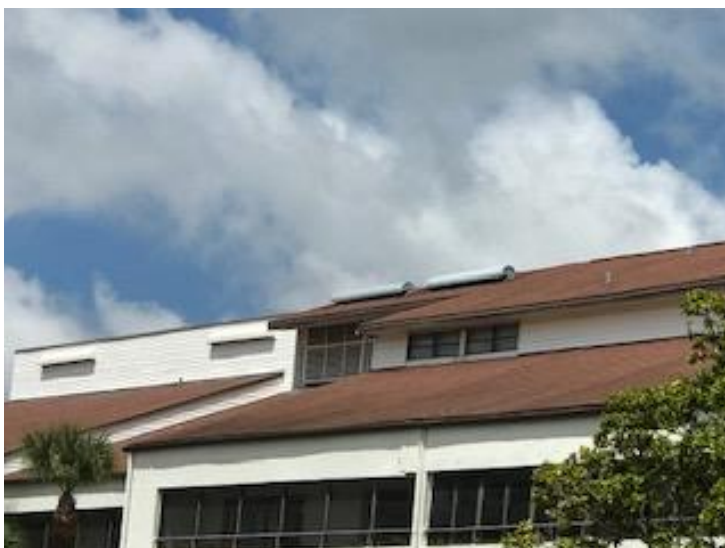
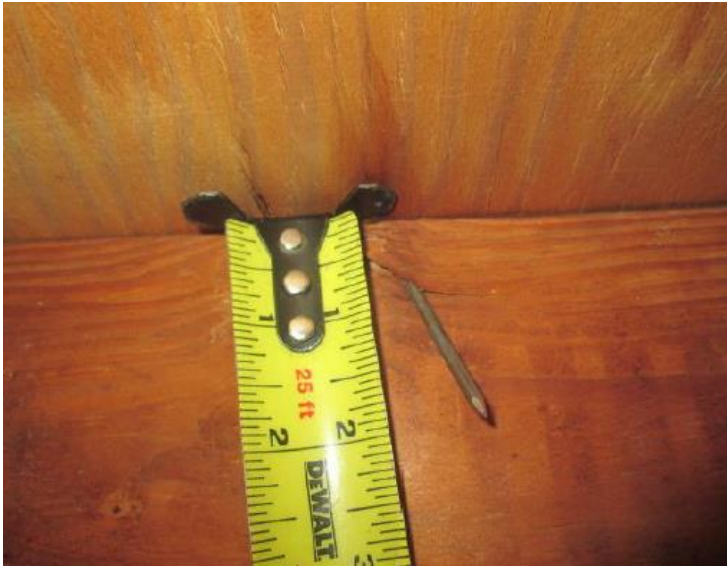
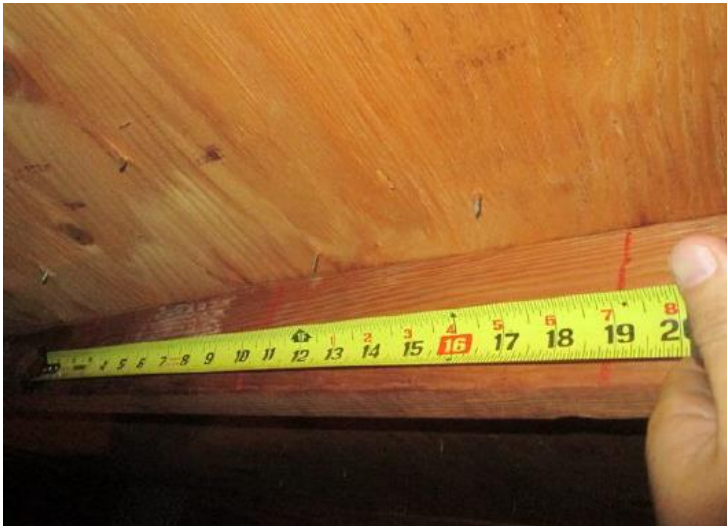
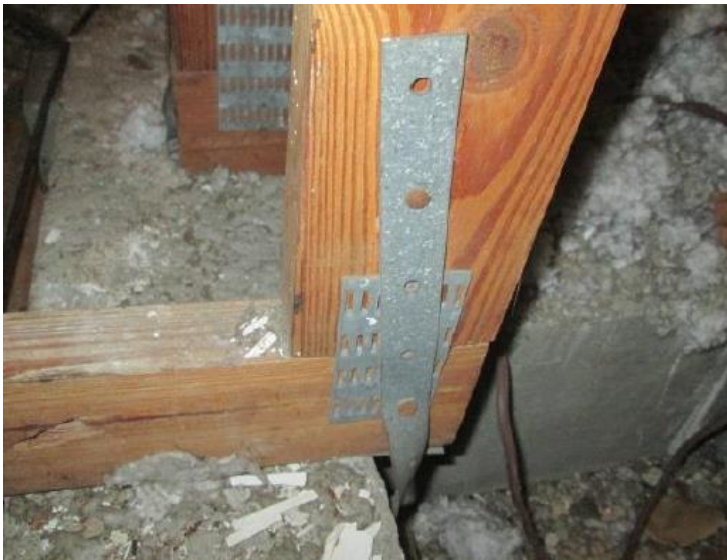
Roof Construction

3. **Roof Deck Attachment:** **Level C**
Comments: Inspection verified 1/2" plywood roof deck attached with 8d nails at a minimum 6" on the edge & 6" in the field.

6. **SWR:** **No**
Comments: Inspection verified no secondary water resistance.
7. **Opening Protection:** **None or Some Glazed Openings**
Comments: Inspection verified no opening protection.
