COMMERCIAL WINDSTORM MITIGATION REPORT (OIR-B1-1802)

Inverness Condominium II Association, Inc.
Building 4, 2585 Countryside Blvd, Units 4101-4313
Clearwater, FL 33761

As of 4/8/2020
FPAT File# MUD2014392

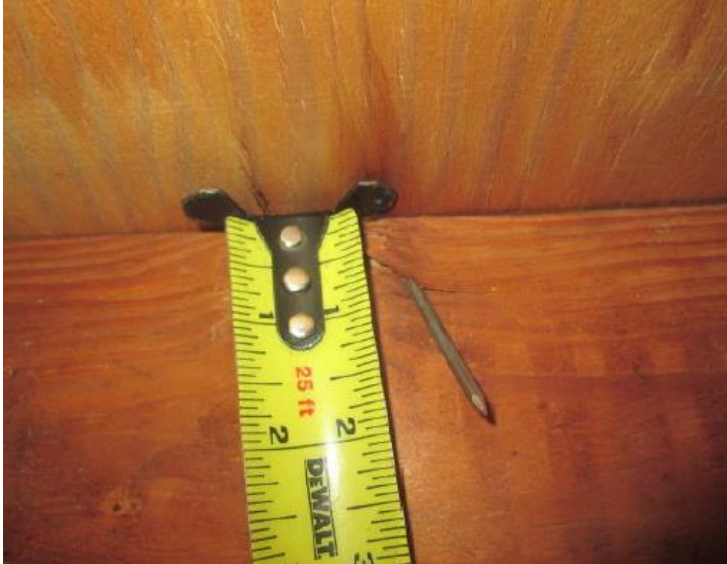
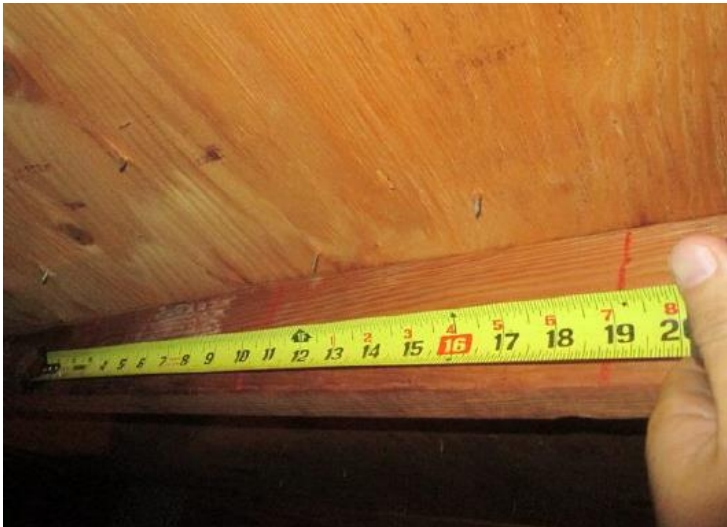
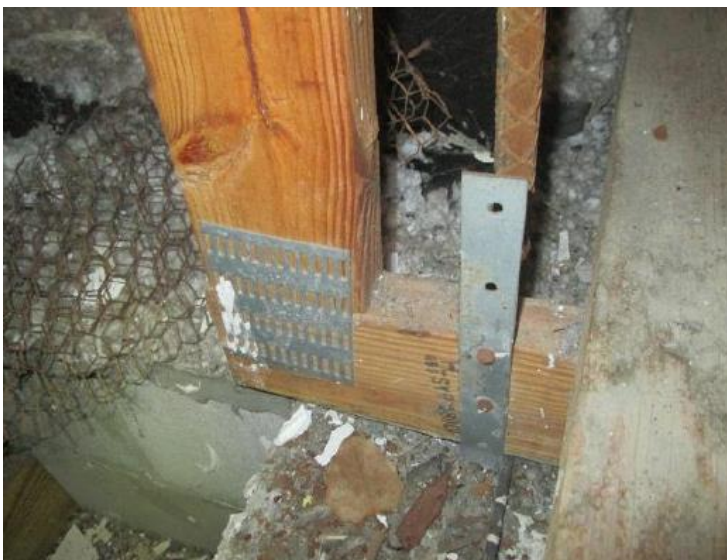
Roof Construction

3. **Roof Deck Attachment:** **Level C**
Comments: Inspection verified 1/2" plywood roof deck attached with 8d nails at a minimum 6" on the edge & 6" in the field.

4. **Roof to Wall Attachment:** **Toe Nails**
Comments: Inspection verified embedded straps fastened with less than three nails.
5. **Roof Geometry:** **Other Roof**
Comments: Inspection verified a gable roof shape.

6. **SWR:** **No**
Comments: Inspection verified no secondary water resistance.
7. **Opening Protection:** **None or Some Glazed Openings**
Comments: Inspection verified no opening protection.
