COMMERCIAL WINDSTORM MITIGATION REPORT

Inverness Condominium II Association, Inc.

As of 4/8/2020

Building 2, 2581 Countryside Blvd, Units 2101-2212, 2301-2313

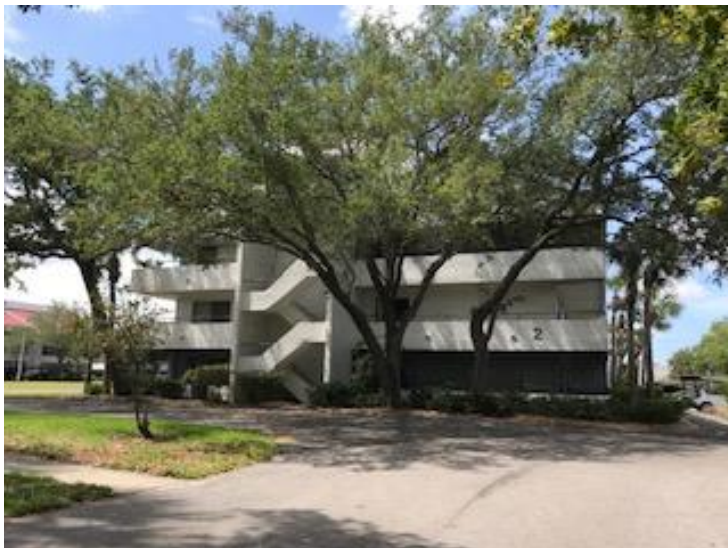
4. **Roof to Wall** **Toe Nails**
Attachment: Inspection verified embedded straps fastened with less than three
Comments: nails.
5. **Roof Geometry:** **Other Roof**
Comments: Inspection verified a gable roof shape.

Exterior Elevation

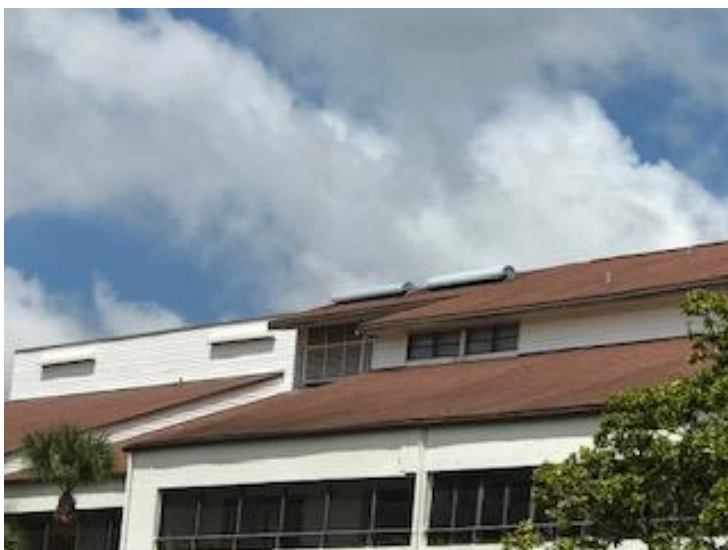
3. **Roof Deck Attachment:** **Level C**
Comments: Inspection verified 1/2" plywood roof deck attached with 8d nails at
a minimum 6" on the edge & 6" in the field.

6. **SWR:** **No**
Comments: Inspection verified no secondary water resistance.
7. **Opening Protection:** **None or Some Glazed Openings**
Comments: Inspection verified no opening protection.

Roof Construction

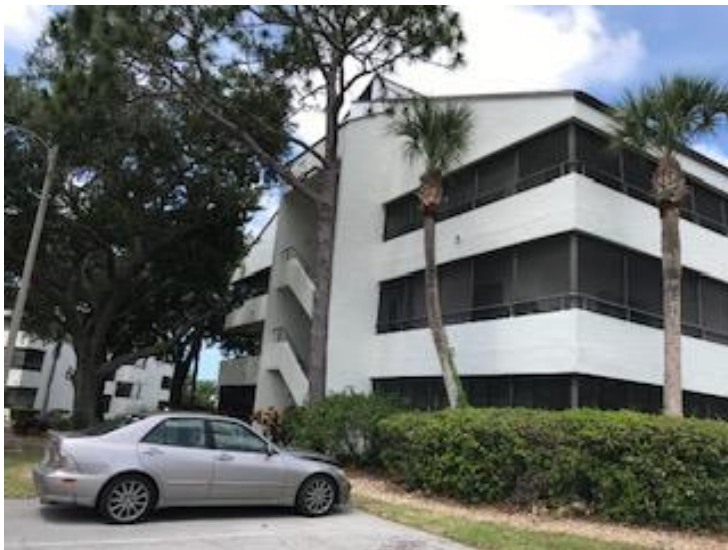
4. **Roof to Wall Attachment:** **Toe Nails**
Comments: Inspection verified embedded straps fastened with less than three nails.
5. **Roof Geometry:** **Other Roof**
Comments: Inspection verified a gable roof shape.

Exterior Elevation

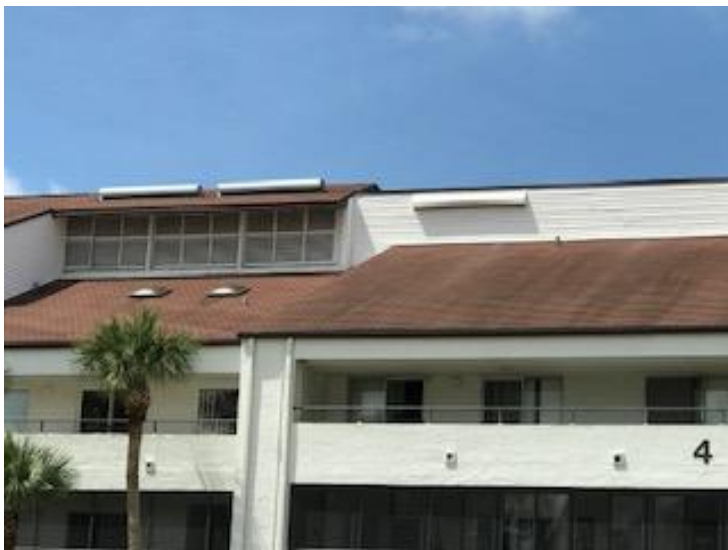
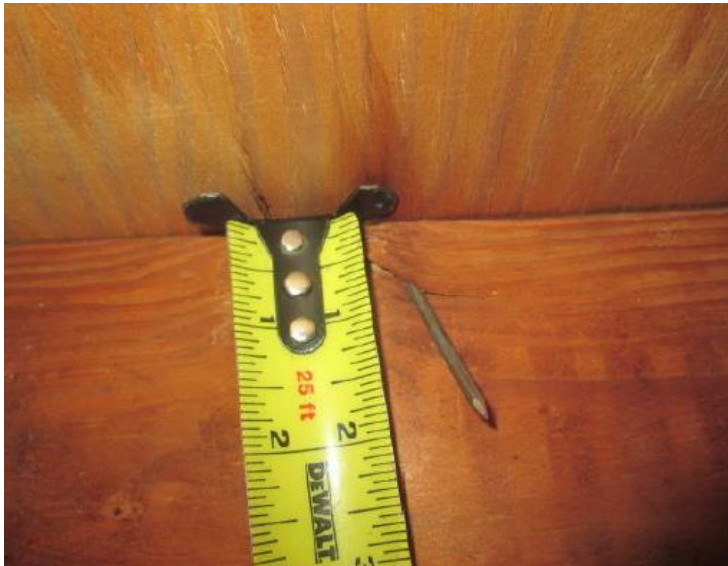
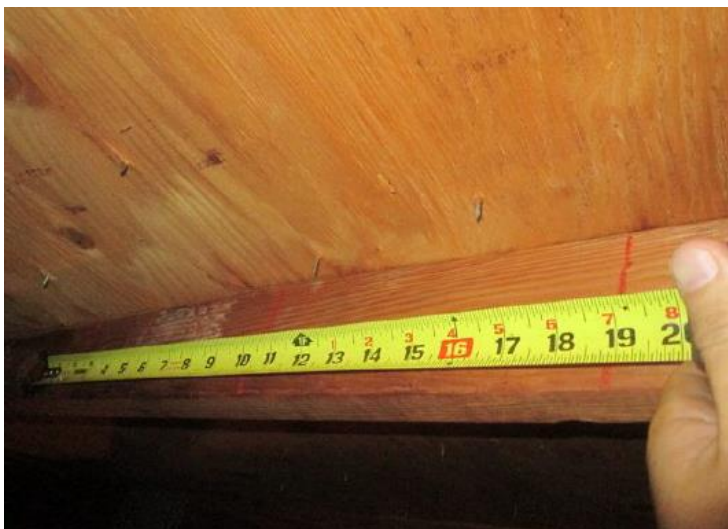
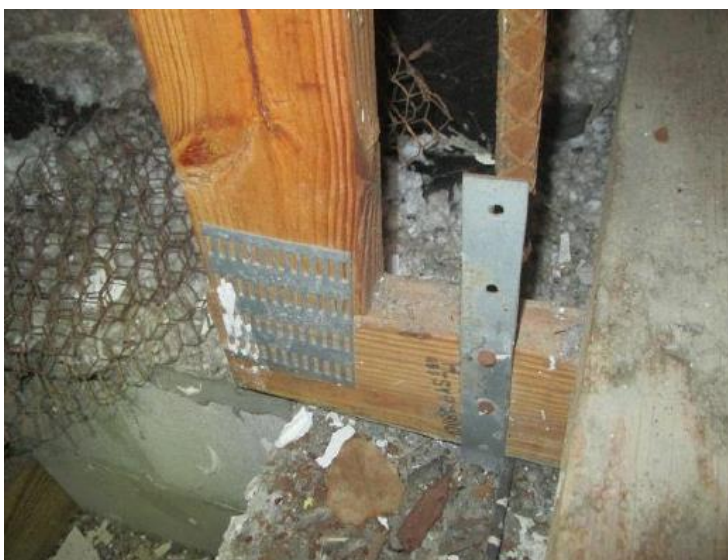
3. **Roof Deck Attachment:** **Level C**
Comments: Inspection verified 1/2" plywood roof deck attached with 8d nails at a minimum 6" on the edge & 6" in the field.

6. **SWR:** **No**
Comments: Inspection verified no secondary water resistance.
7. **Opening Protection:** **None or Some Glazed Openings**
Comments: Inspection verified no opening protection.

Roof Construction
